Annex B

Operation “Night Eagle” – Safety Lapses Identified

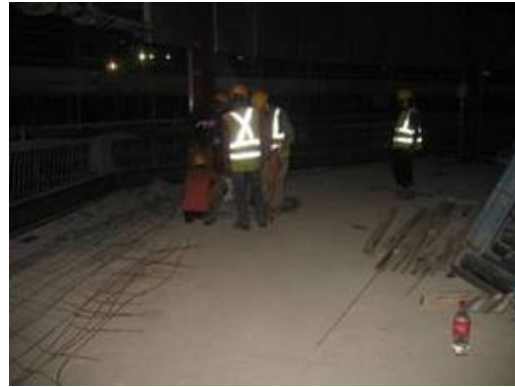
Photos taken with flashlight by the OSH Inspectorate revealed that workers were working with insufficient lighting in that area.

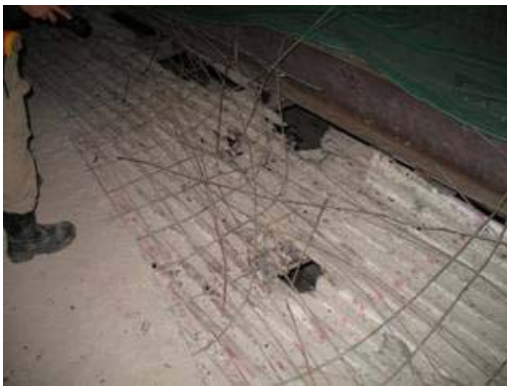
Gaps and corroded openings were found on the existing bondeck. Workers were seen stepping on the existing bondeck while working at the area.

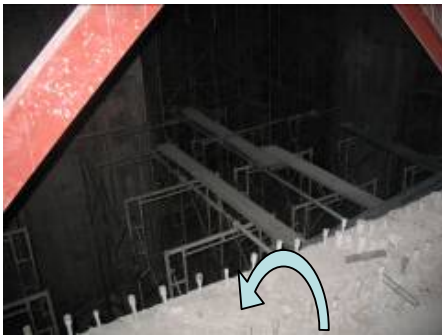
Failure to provide effective guard-rails , barriers or other equally means to prevent fall to open side or opening through which a person is liable to fall more than 2 metres

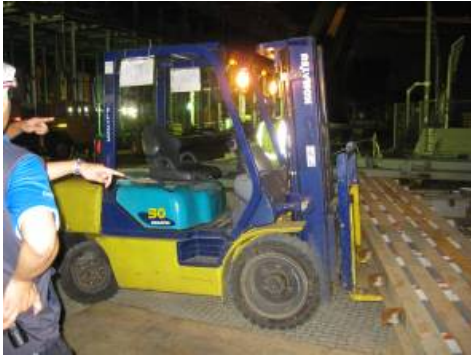
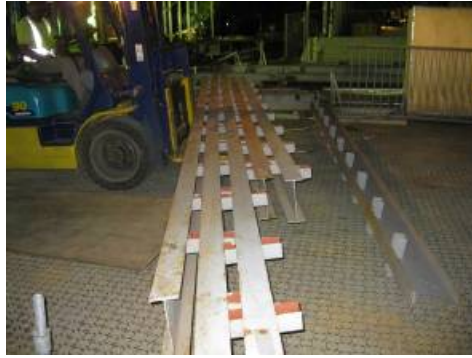
Failure to implement reasonably practicable measures and safe work procedures to minimise and control the risk posed for works involving the transfer of the materials using forklifts.

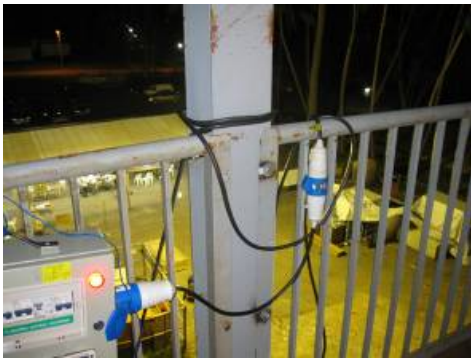
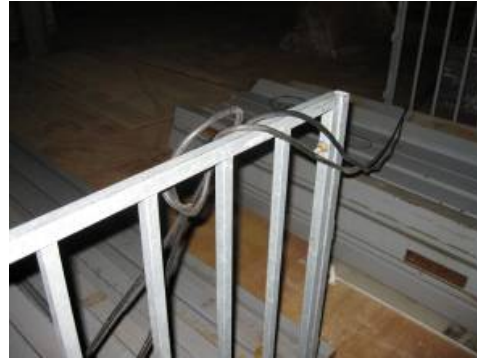
Failure to ensure that all electric wiring was supported on proper insulators.

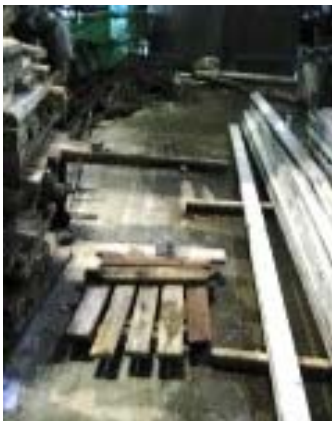
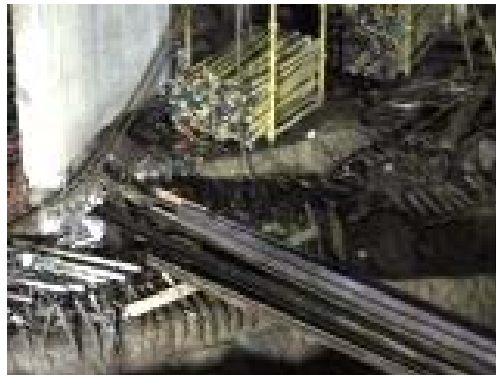
Failure to keep the passageways and places of work, free from debris and protruding objects that could cause tripping.

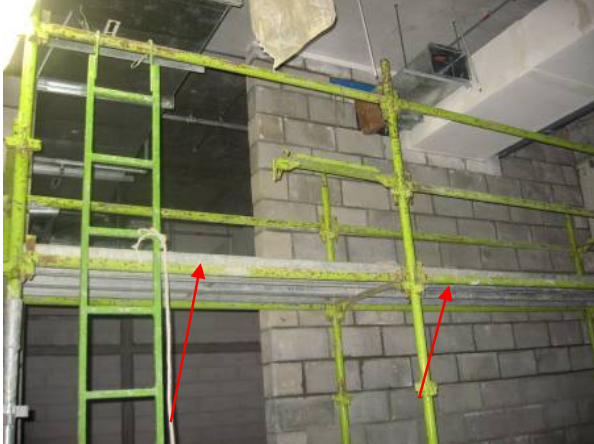
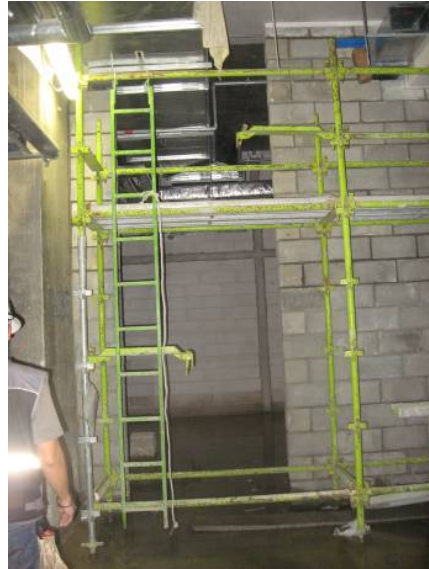
Failure to provide every side of work platforms with guardrails and toe-boards.

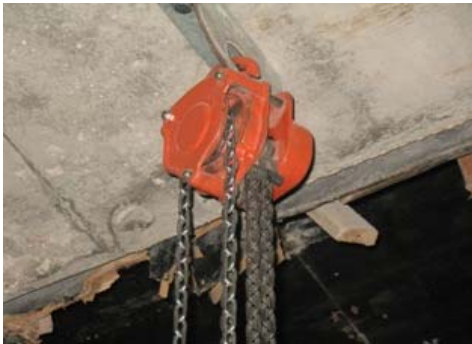
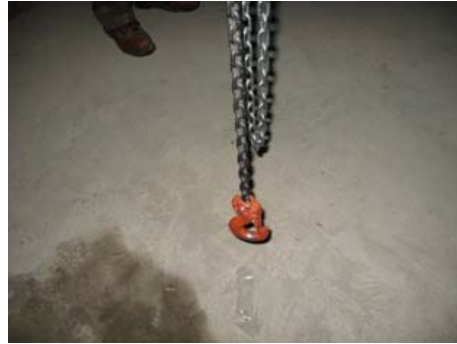
Failure to ensure every lifting appliance was marked conspicuously with its safe working load and a distinctive number or any other means of identification.

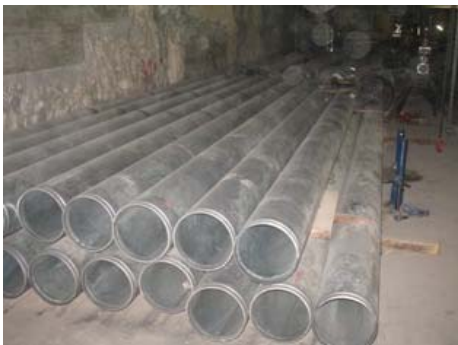
Failure to implement safe work procedures to control risk arising from the stacking, lifting and transferring of galvanised pipes.

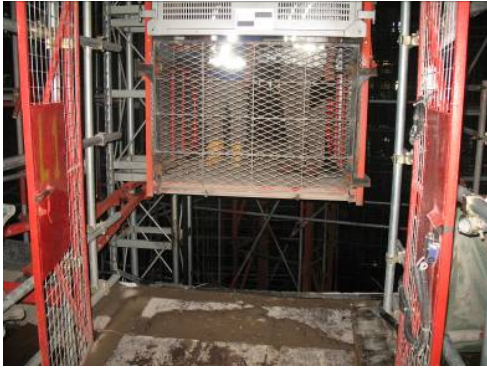
Failure to ensure that the interlocking device of the passenger hoist bearing was in good working condition such that the cage or platform cannot be moved away from the landing until the gate is closed

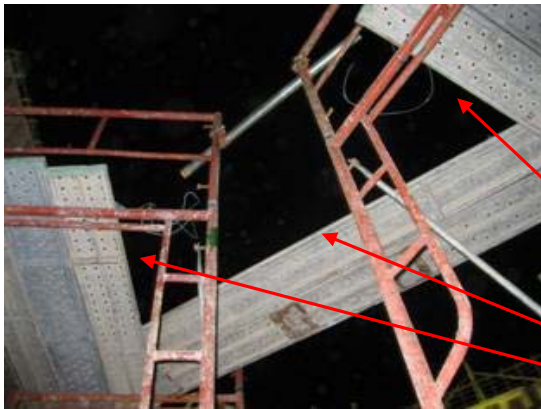
Failure to provide every side of the work platform from which a person was liable to fall more than 2 metres with toe-boards and guard-rails

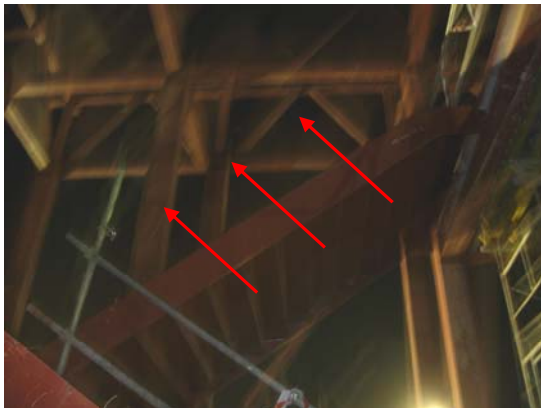
Failure to provide and maintain handrails on one side of the staircases at multiple locations

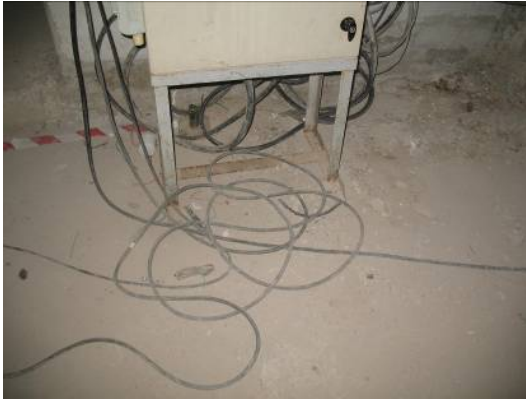
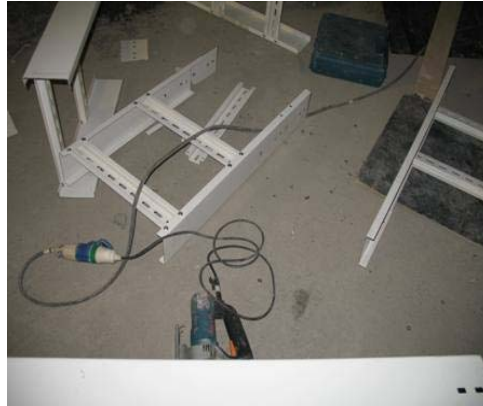
Failure to ensure that the electrical extension cable used to connect the electrical cutter shall not be left on the ground unless it was provided with adequate protection to withstand the wear and tear to which it may be subjected to.
