Operation “Seagull”– Safety Lapses Identified

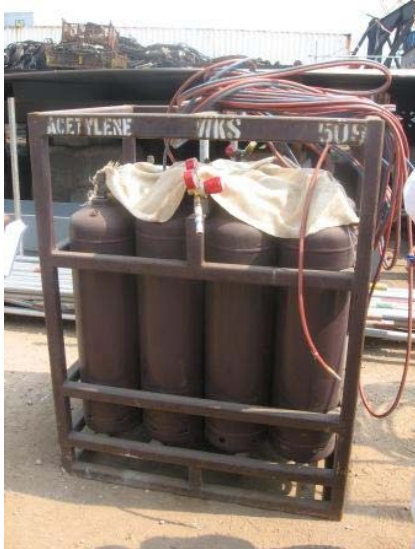
Failed to ensure that all equipment and fitting used for carrying out hot-work are inspected and tested by a competent person once every 14 days to ensure that they are free from defects

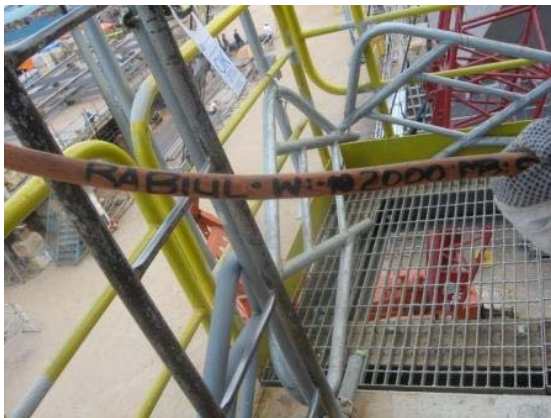
Failed to ensure that welding cables are inspected by a competent person once in every 30 days

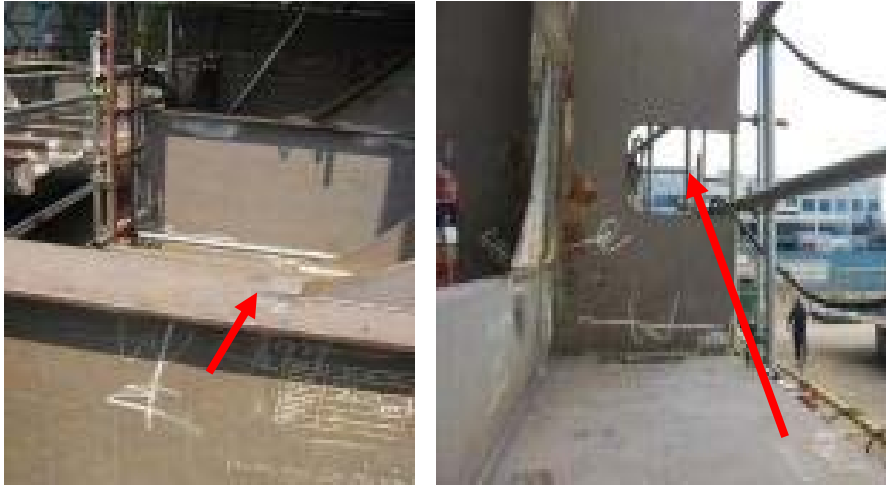
Failed to take measures to ensure safe means of access to and egress from the workplace for all persons within the premises

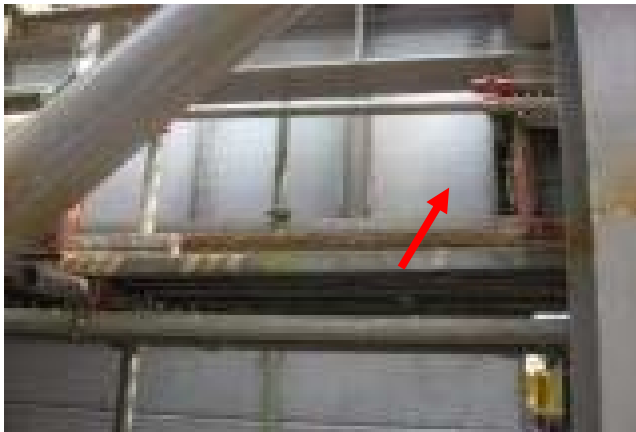
Failed to provide effective barrier on every side of the work platform from which a person might fall more than 2 metres

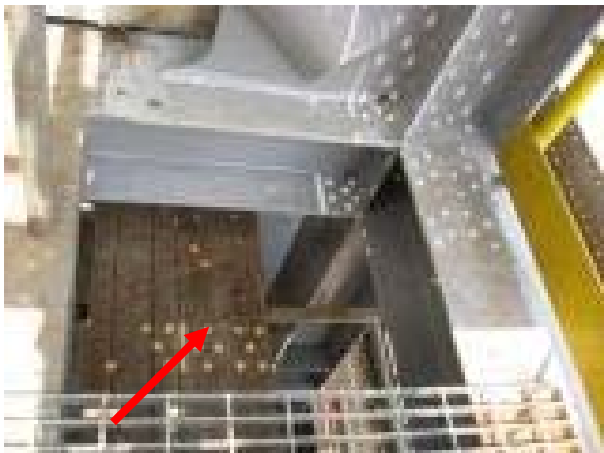
Failed to provide effective barriers to prevent falls through openings where a person might fall more than 2 metres

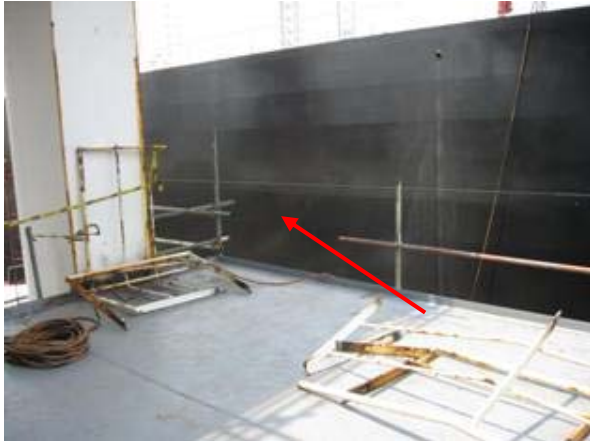
Failed to provide effective barriers to prevent falls through open sides from which a person might fall more than 2 metres

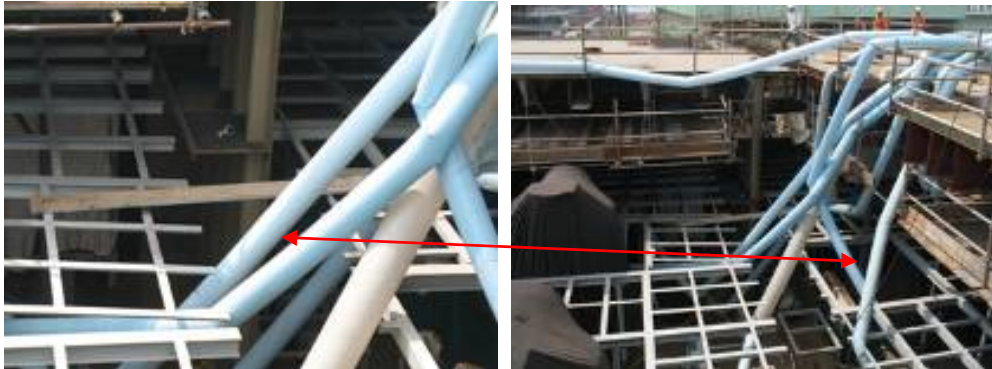
Failed to provide safe means of access and egress for scaffold erectors erecting the hanging scaffold

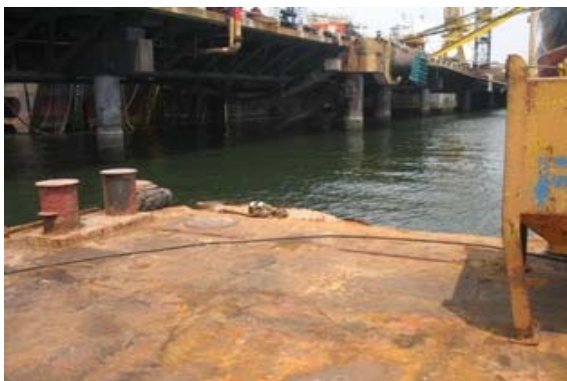
Failed to cover or guard openings through which a person might fall more than 2 metres by installing effective guardrails, barriers or other equally effective means to prevent fall,.

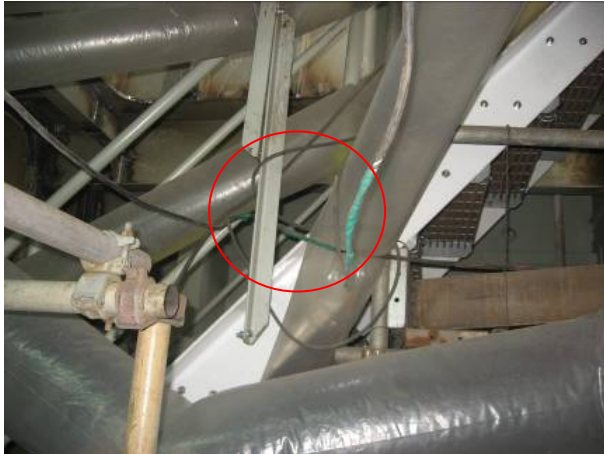
Failed to ensure that all electrical connections are in accordance with accepted principles of sound and safe practice. Electrical wires were branched out with improper methods.
