P R E S S R E L E A S E

Annex

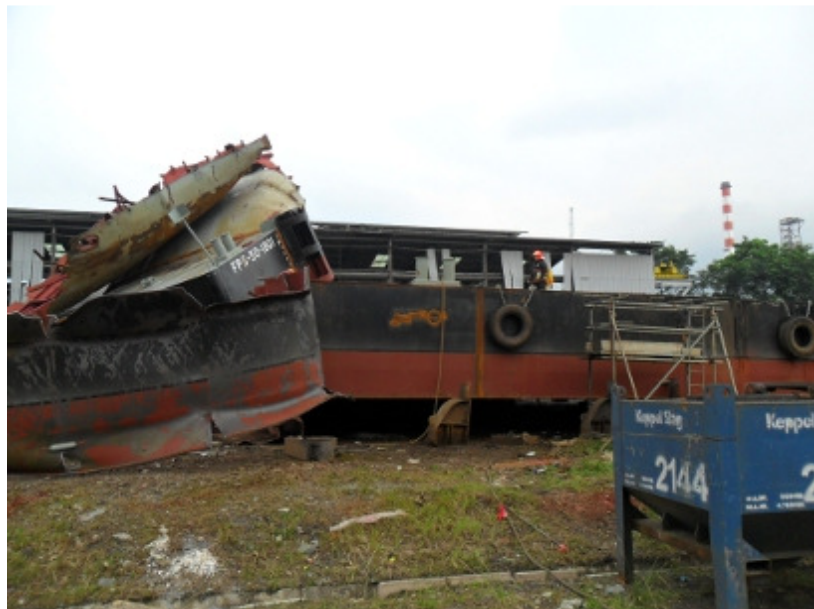
Photograph 2: The Port side of the barge, with its front part damaged by the blast

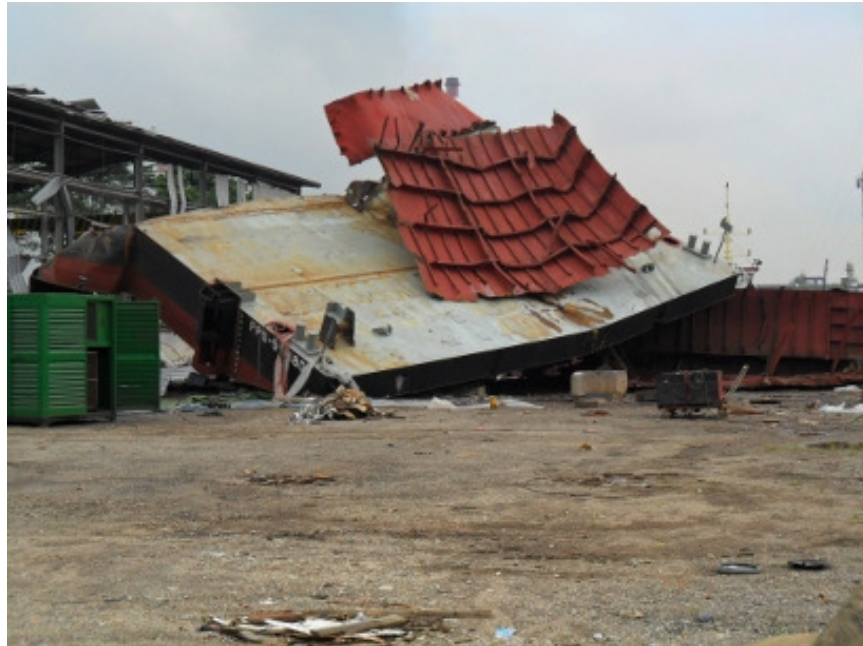
Photograph 3: The front part of the damaged barge

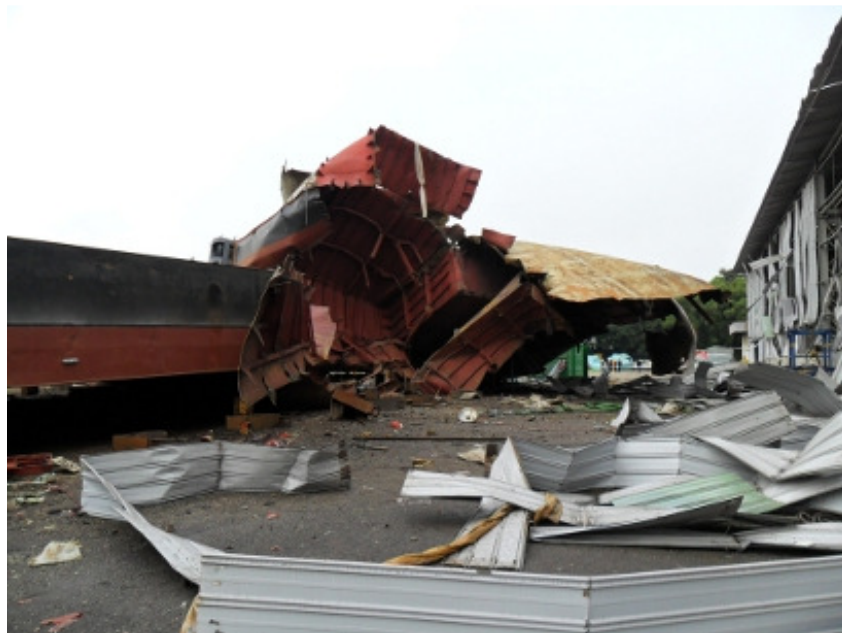
Photograph 4: The view of the damaged barge from its Starboard side. The workshop is on the right side of the photograph.

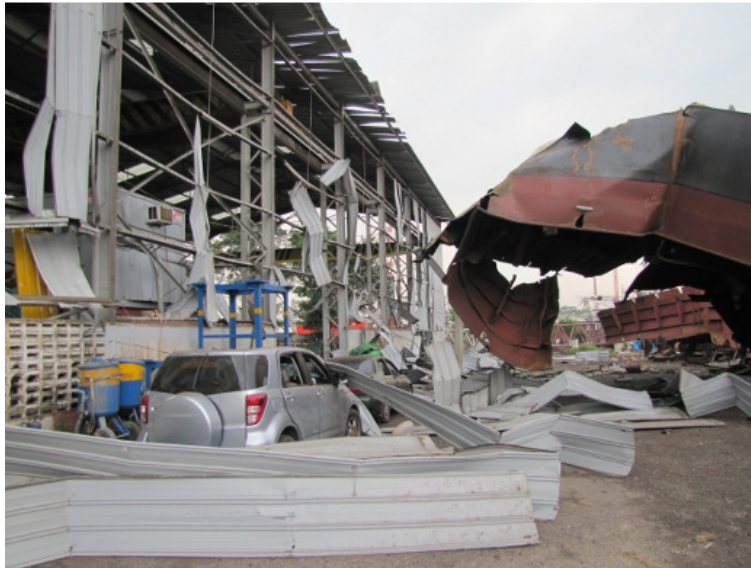
Photograph 5: The wall panels of the workshop beside the barge were dislodged by the blast

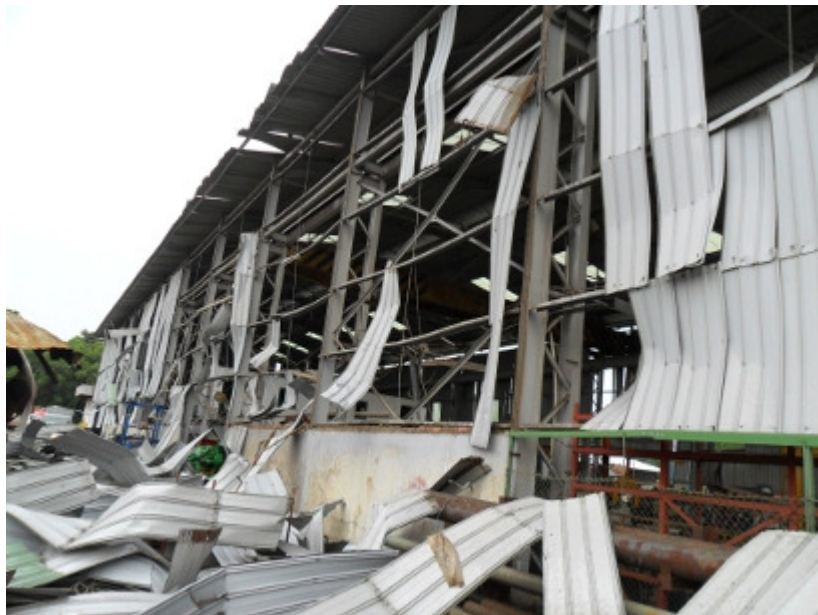
Photograph 6: Another view of the workshop
