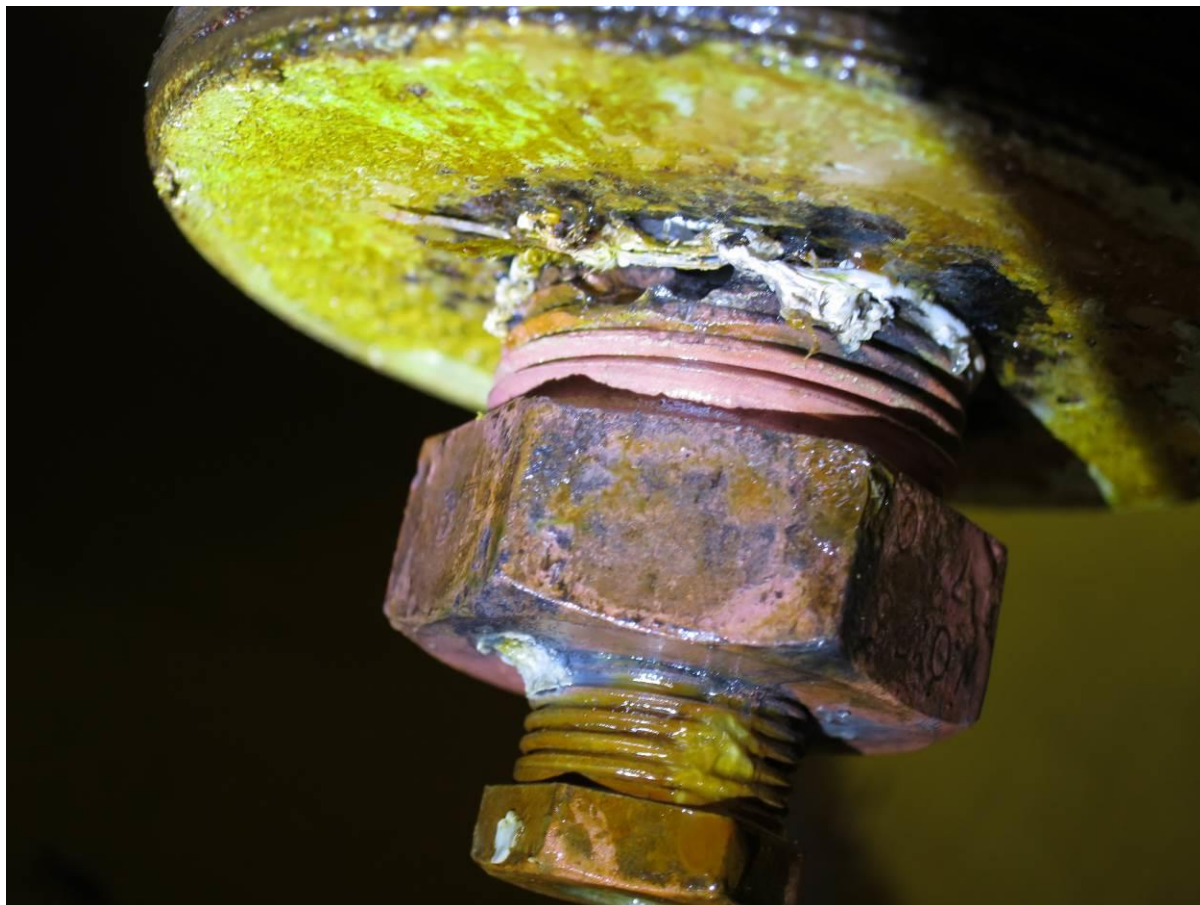
**Photograph showing corroded fusible plug**
