**Annex B – Photos from Worksites of Wah Khiaw Developments Pte Ltd and KG Plasterceil Pte Ltd**

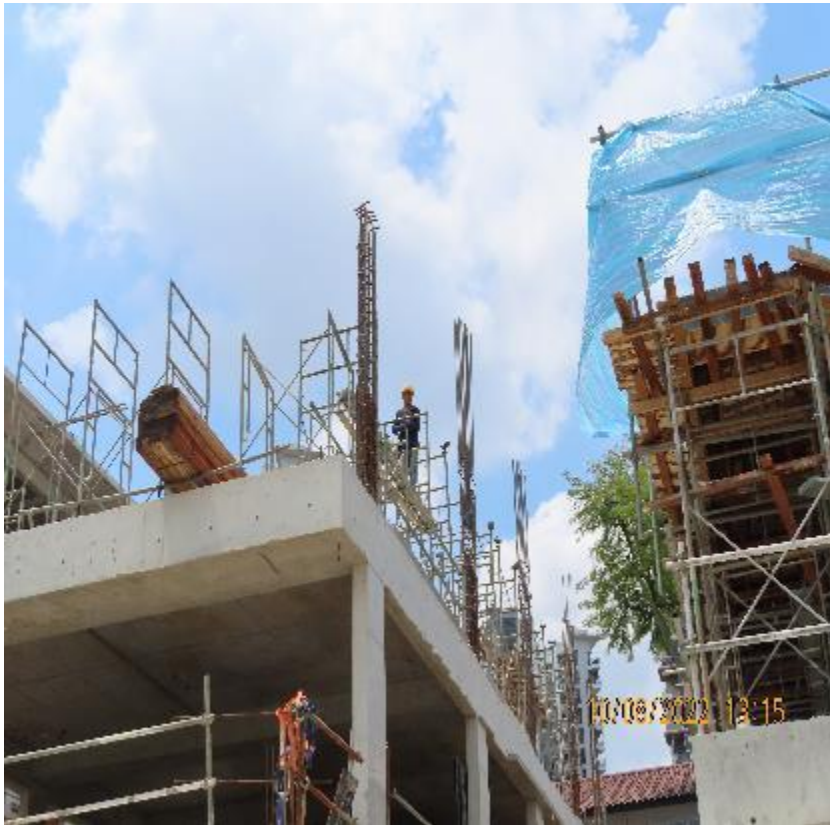
A worker was seen performing work at the edge of the third floor of the structure, without barricades or a fall arrest system. The worker was not wearing a safety harness.

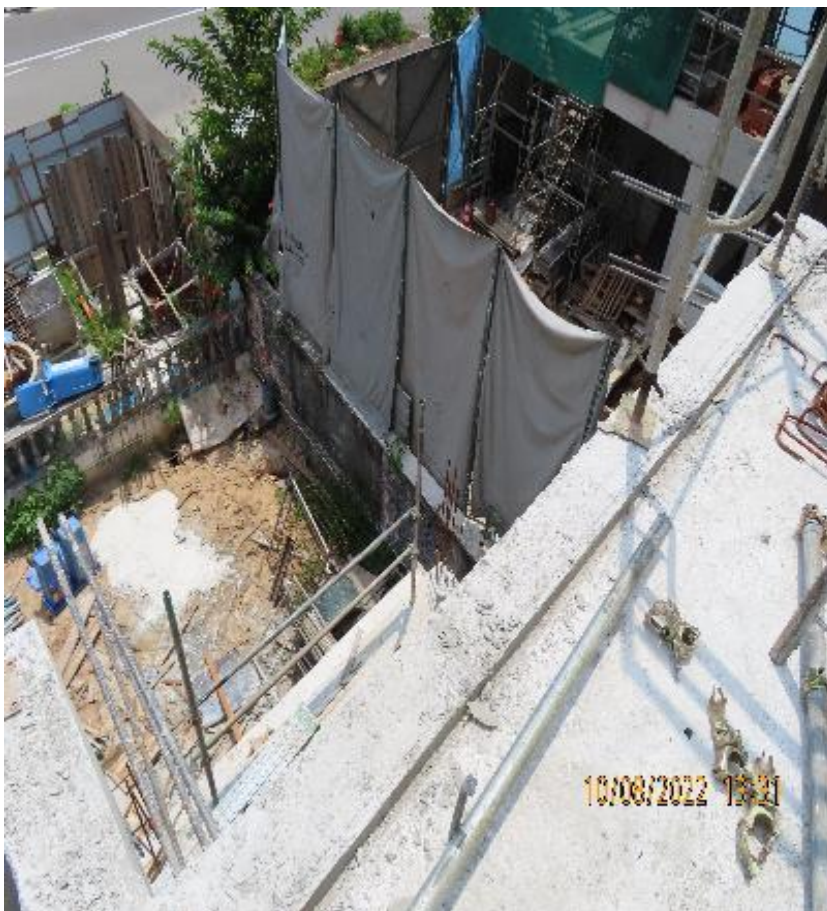
Open sides, which are edges without barricades, were observed at multiple locations at the site.

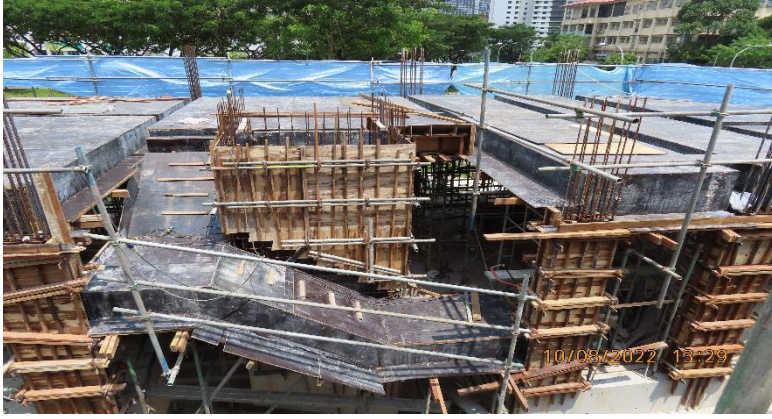
No provision of proper means of access and egress.

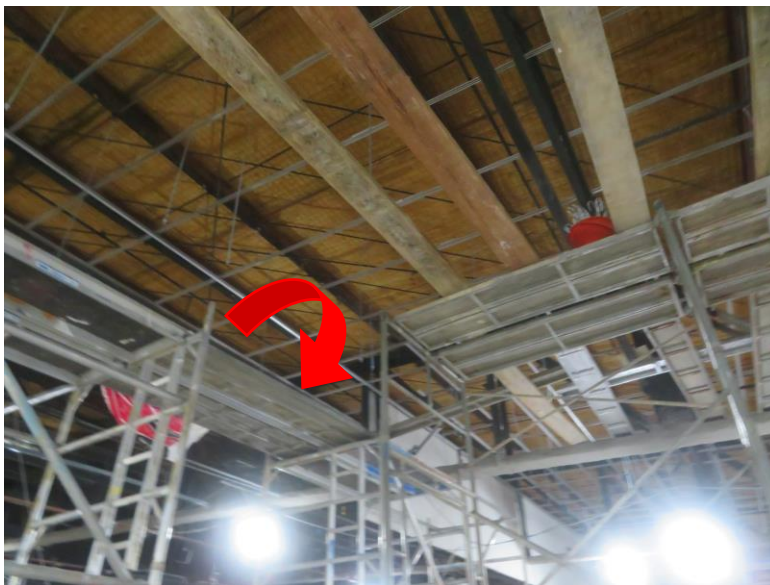
Toe-boards and guardrails were not provided on the sides of the work platform where workers could fall from more than 2 metres of height.

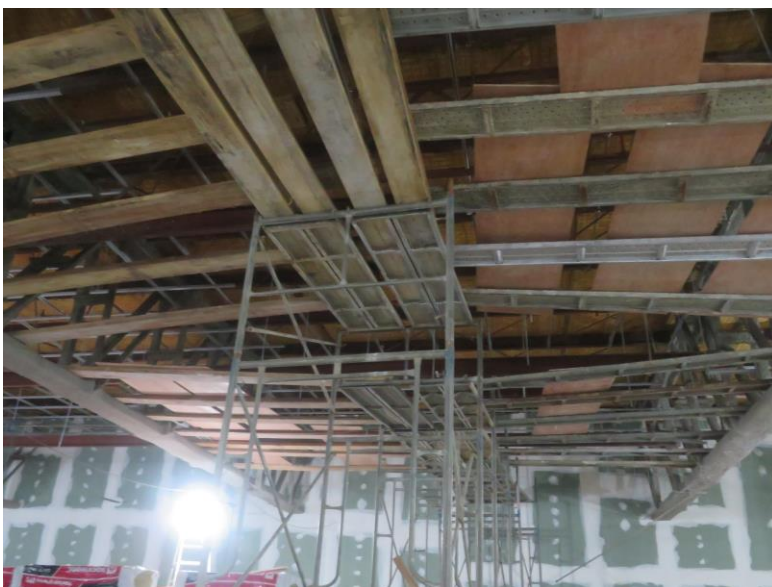
Workers were found working on work platforms that were not closely boarded and properly secured, which may lead to accidental displacement (i.e. shifting of the platform).

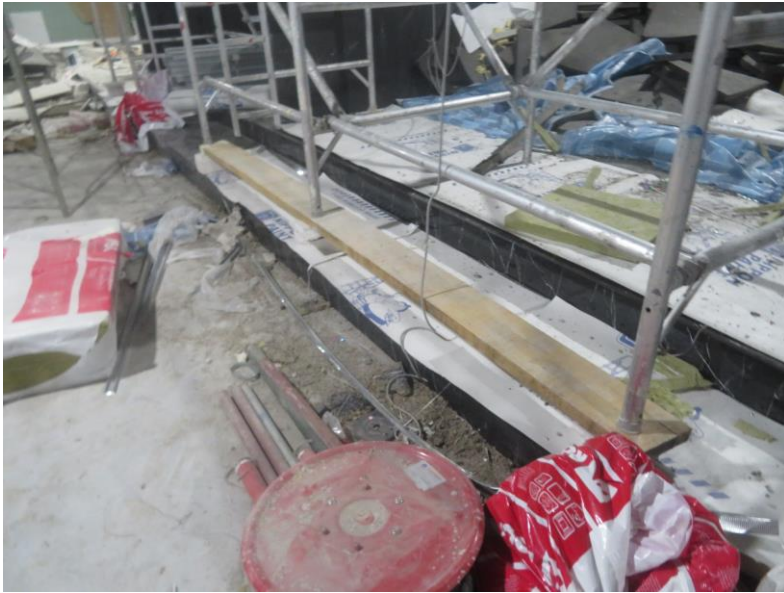
Some of the scaffold structures were erected on void areas, whereas others were placed on unstable foundations.
