Factsheet

20 Nov 2009

RECENT ACCIDENTS INVOLVING USE OF GONDOLAS

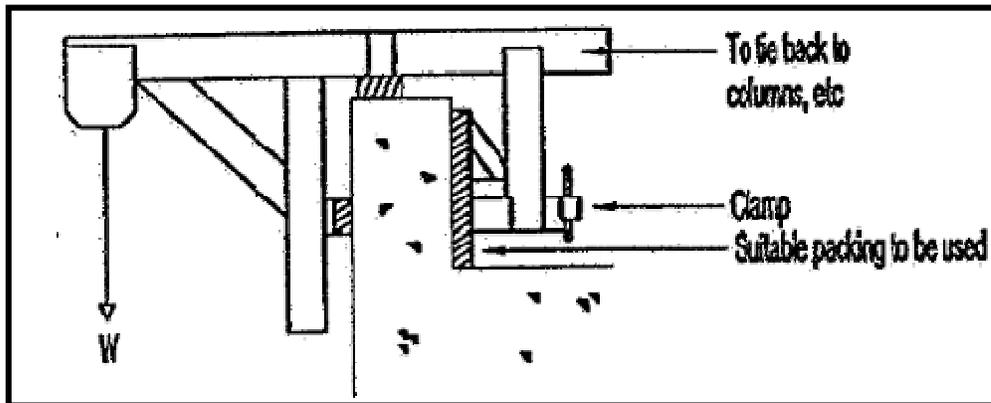
Annex C

- a. Where wall clamps are used as part of the anchorage system (refer to Annex C), they must be installed on a structure which is capable of withstanding the stresses imposed on it. Where there is contact between the clamps (metal) and the wall (plaster) adequate packing must be used. It is also recommended that sufficient clearance be maintained between the wall clamps and other parts of the supporting structure (other than the designated padded areas)

Diagram of a typical wall clamp

- Point of anchorage should withstand stress; and
- Secure and adequate packing provided to prevent contact with non-structural elements
