Corrosion in Autoclaves

Findings from Recent Inspections

Occupational Safety and Health Division Ministry of Manpower

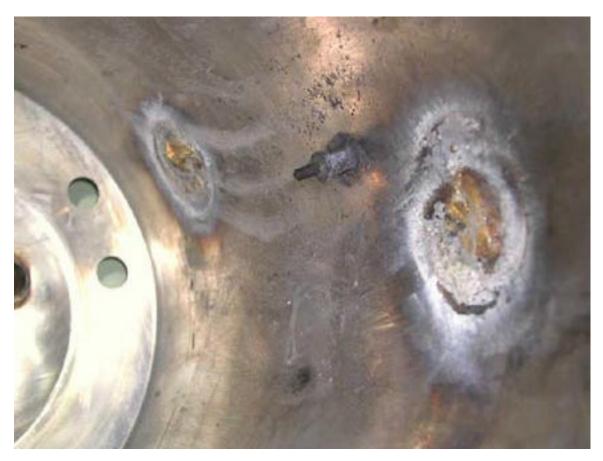
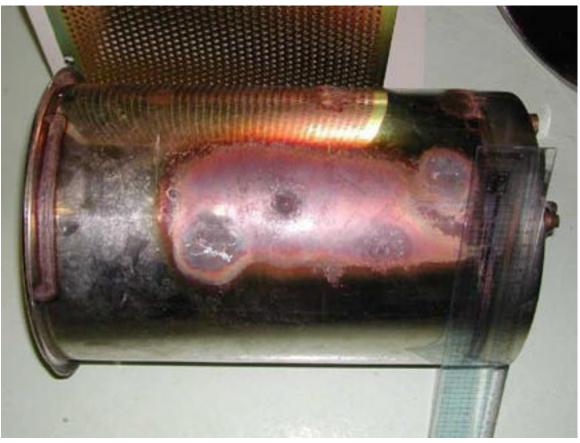
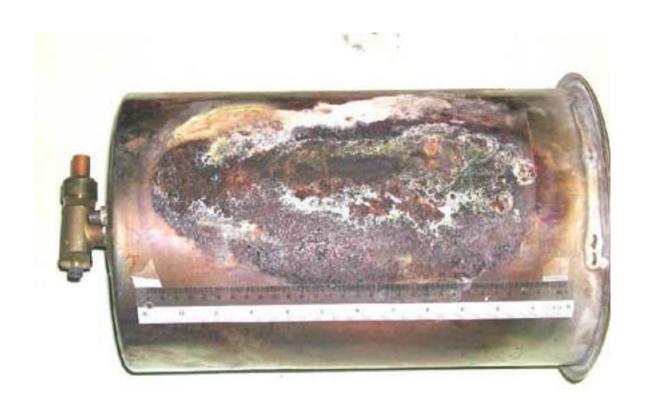
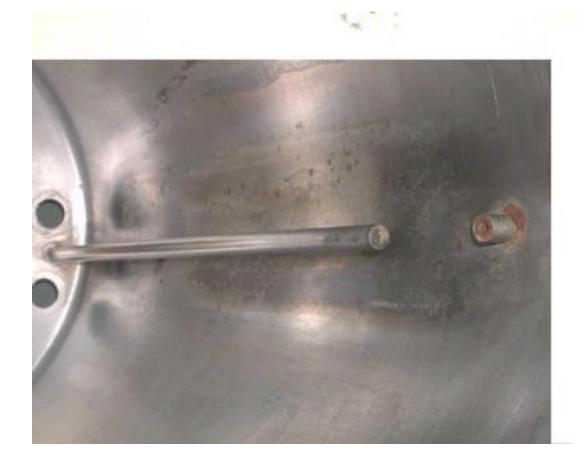
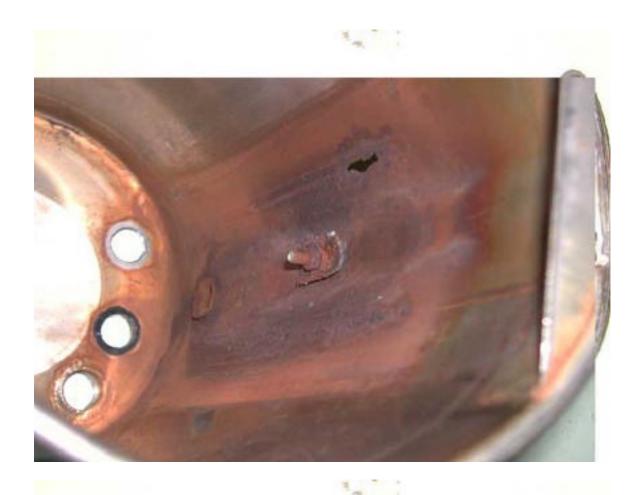
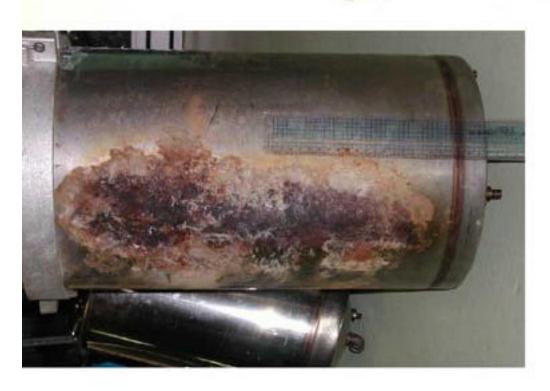
Photographs showing corrosion in autoclaves

The photographs in the report show the extent of corrosion in some autoclaves that were inspected recently despite the fact that they were made from stainless steel and that they had been in service for a relatively short period of only about 5 to 6 years.

It is indeed not normal for an autoclave to exhibit such appalling conditions as shown, after only 5 years of service as most autoclave chambers are made of stainless steel that should not corrode. However, stainless steel is susceptible to chlorine attack that would cause it to corrode quickly. It is suspected that the main cause of the corrosion was the use of tap water (which is chlorinated).

Users of autoclaves are strongly advised to use distilled water for the operation of their autoclaves to prevent similar deterioration that could lead to a catastrophic failure of the autoclave.
