Photographs of WAH Violations

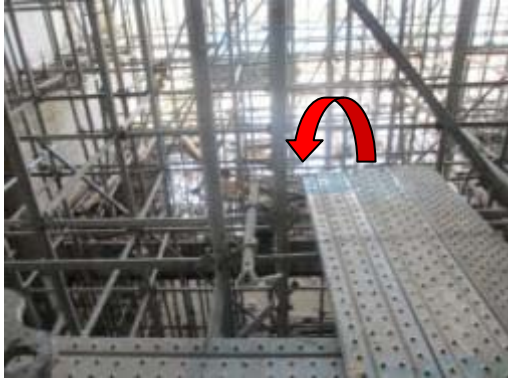
<ul style="list-style-type: none"> The occupier at this worksite failed to implement adequate fall prevention measures, at this extended work platform. Workers at the site faced the risk of falling 2 metres into a void area.
2

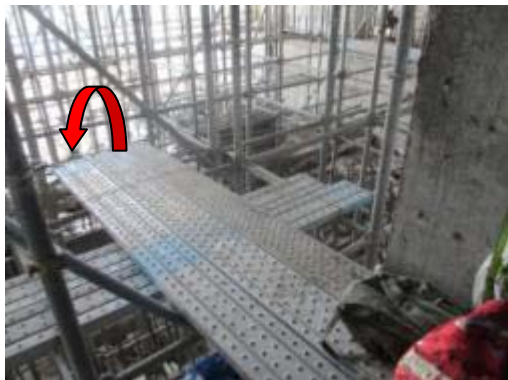
<ul style="list-style-type: none"> The occupier at this worksite failed to implement adequate fall prevention measures, at this extended work platform. Workers at the site faced the risk of falling 2 metres into a void area.
3

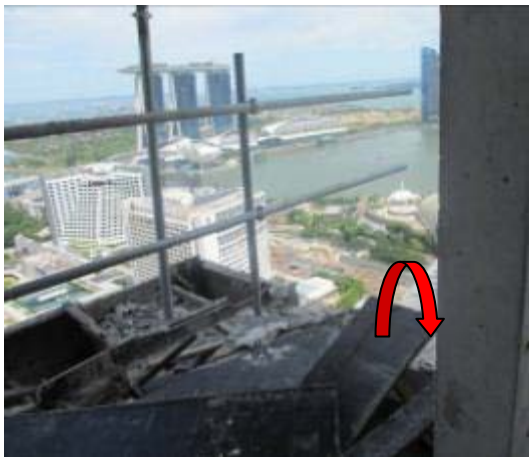
<ul style="list-style-type: none"> The occupier at this worksite failed to implement fall prevention measures at an open side of the 33rd storey of a building under construction. An inspection of the worksite showed that the entire level had housekeeping problems that posed trip hazards to workers.

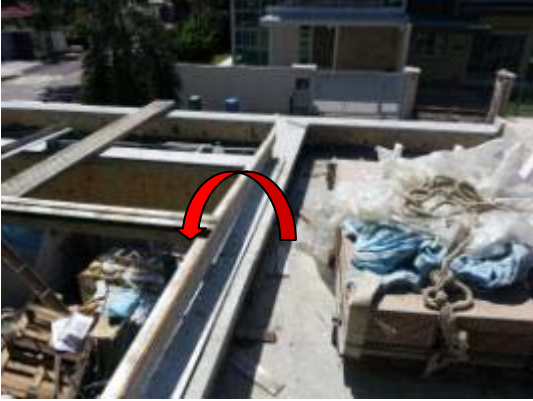
4

<ul style="list-style-type: none">• The occupier at this worksite failed to implement fall prevention measures at an opening. Workers at the site faced the risk of falling more than 2 metres through the opening.
5

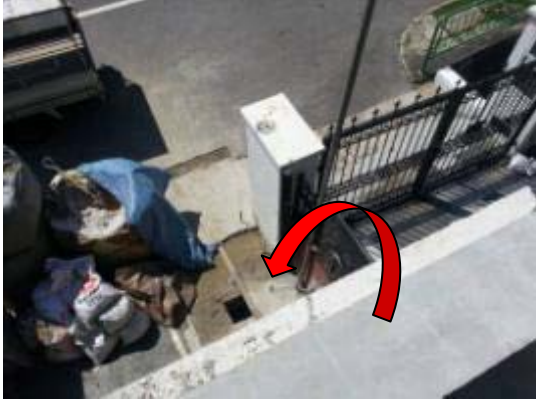
<ul style="list-style-type: none">• The occupier at this worksite failed to implement fall prevention measures at this roof of a car porch r under construction.
6

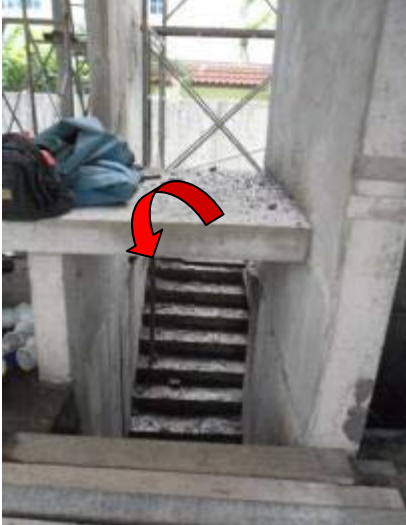
<ul style="list-style-type: none">• The occupier at this worksite failed to implement fall prevention measures along the multiple open sides at this work area. Workers at the site faced the risk of falling more than 2 metres through the open sides.

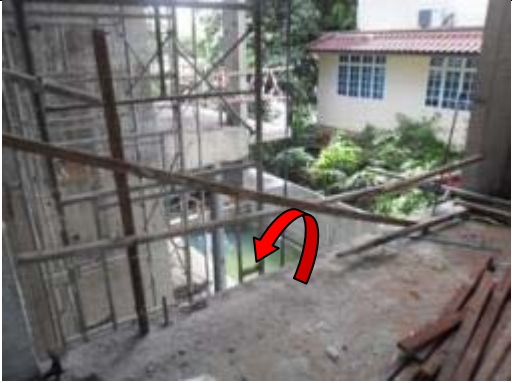
7

<ul style="list-style-type: none">• The occupier at this worksite provided poor guardrails that were not properly maintained. The guardrails did not serve its purpose of fall prevention.
8

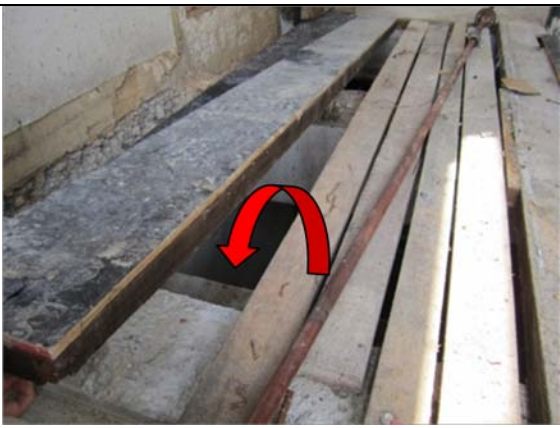
<ul style="list-style-type: none">• The occupier at this worksite had allowed wooden planks to be used to cover an opening which could lead to a 2 metre fall, but the wooden planks were not properly secured. Thus, they could be accidentally moved.
9

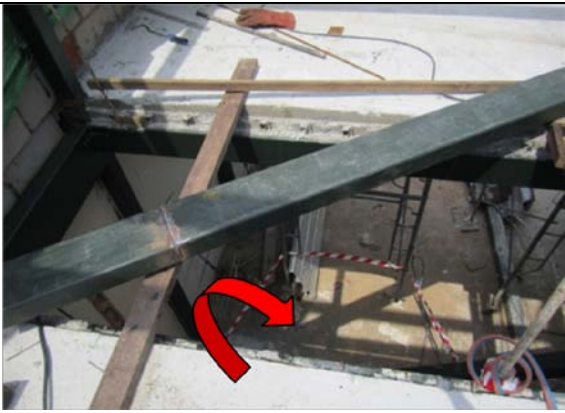
<ul style="list-style-type: none">• The occupier at this worksite did not properly cover this opening, through which a worker could fall more than 2 metres.
