Spate of Crane-related Dangerous Occurrences in First Quarter of 2015

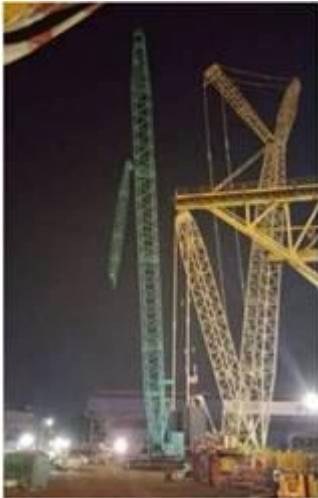
Date of incident: 19 Jan 2015

A crawler crane had just completed a lifting operation at a workplace in Jurong when the crane operator attempted to concurrently move his crane while hoisting up the auxiliary hook at the same time. Without realising that the hook had exceeded its allowable limit, the operator continued hoisting, resulting in the hook hitting the fly jib. The fly jib buckled and was left dangling from the boom tip. No one was injured in the incident.
