Details of three fatal accidents

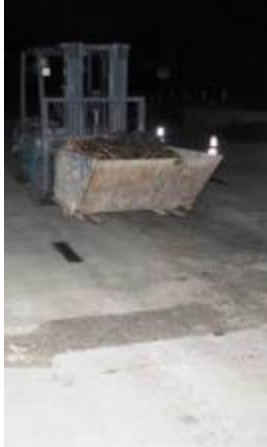
What happened: On 19 May 2016, a worker was patching up holes on the floor of a viaduct under construction when he was struck by a forklift carrying construction material. The worker was conveyed to hospital where he subsequently passed away.

The forklift involved in the accident.
(photograph taken on the night of the accident)

| Good practices to adopt | Bad practices to avoid |
| <ul style="list-style-type: none"> • Clearly mark out work areas to prevent vehicles from entering. • Provide workers with reflective vests to increase their visibility to those in the area. • Forklift operators must always have a clear line of sight. | <ul style="list-style-type: none"> • Ineffective planning of onsite traffic management. • Condoning risky driving behaviour. |

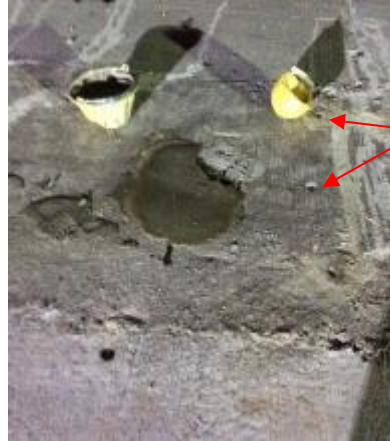
Examples of holes on the floor that the worker was to patch up with cement.

Some of the holes to be patched.

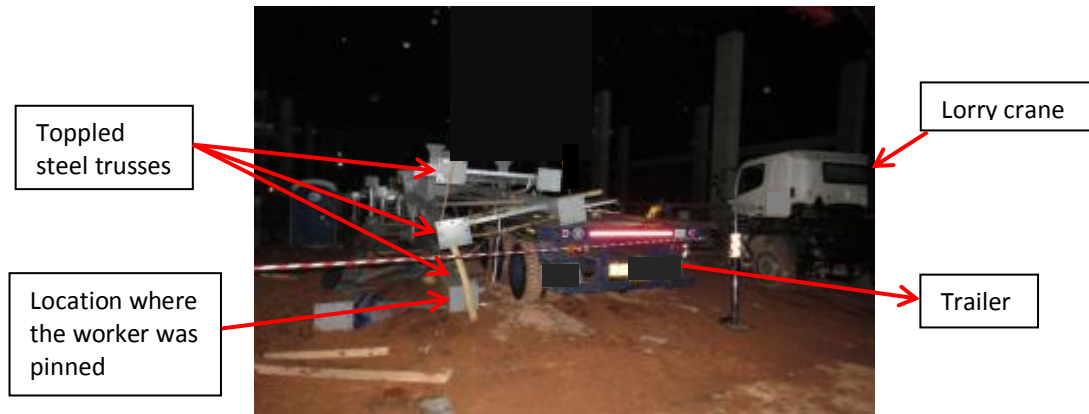
What happened: On 23 May 2016, four steel trusses on a trailer bed were to be unloaded from the trailer. When the first steel truss was lifted away by a lorry crane, the three remaining steel trusses toppled. A worker was pinned by one of the steel truss that had toppled from the trailer and sustained fatal injuries.

Overview of the accident site
(Photograph taken in the night of the accident)

| Good practices to adopt | Bad practices to avoid |
| <ul style="list-style-type: none"> • Prevent remaining load from falling off by using stanchions or steel frames. • Workers are to keep clear of the area during lifting operations. | <ul style="list-style-type: none"> • Failure to secure loose load. • Poor control of workers' movement within the work area. |

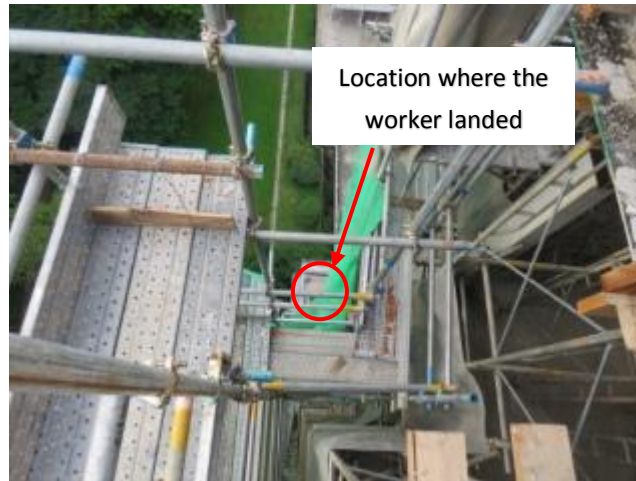
What happened: On 24 May 2016, a worker was carrying out carpentry works on the roof level. He made his way down to the lower level using a scaffold erected at the exterior of a building under construction. He was climbing down the scaffold when he fell about 13 floors from the scaffold. He was pronounced dead at the scene by attending paramedics.

Scene of accident

| Good practices to adopt | Bad practices to avoid |
| <ul style="list-style-type: none">• Provide safe and unobstructed access and egress.• Establish and clearly communicate proper access routes. | <ul style="list-style-type: none">• Poor work space planning. |
