FACTSHEET ON OPERATION TALON

About “Operation Talon”

Annex A(i)
Operation Talon Cases

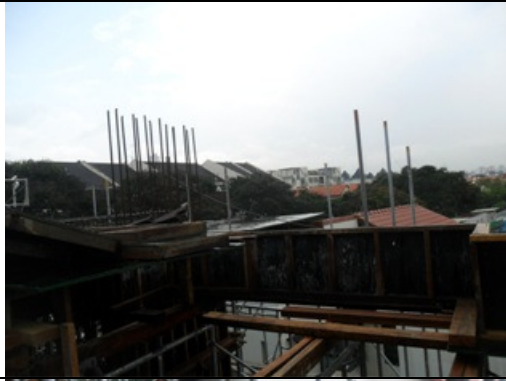
Unsafe work at height	On the fourth storey of the building, workers were erecting formwork (concrete mould) structures without fall protection, exposing them to the risk of falling off the structure.
2

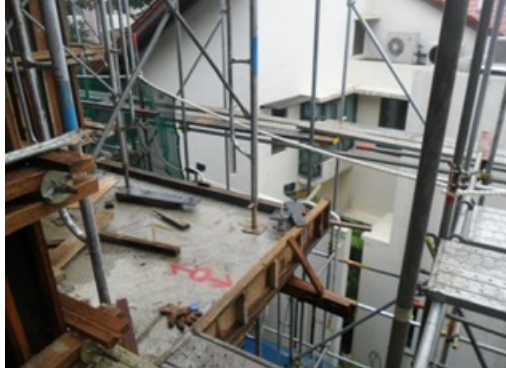
Unsafe work at height	On the third storey of the building, no barricade was set up to prevent workers from falling off an open edge of the structure.

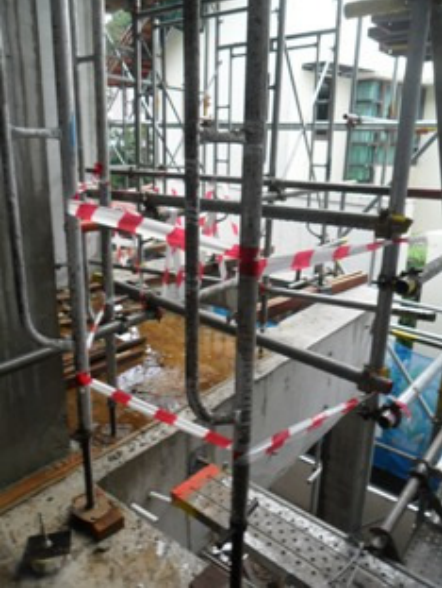
3

<p>Unsafe work at height</p>	<p>On the second storey of the building, plastic tapes were used as barricades for scaffolding gaps. These plastic tapes were ineffective barricades that would not prevent a worker from falling off the open edge of the structure.</p>
4

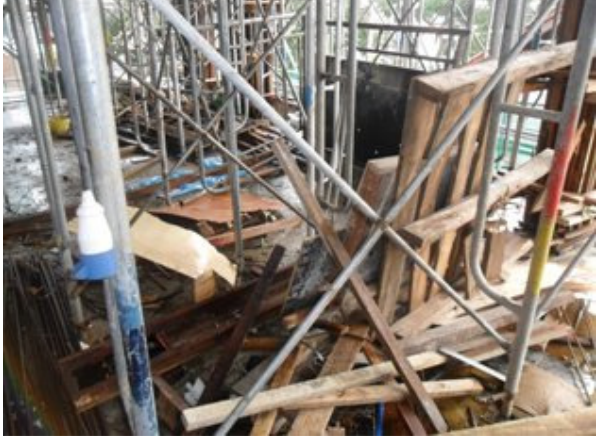
<p>Poor house-keeping</p>	<p>Generally poor housekeeping was observed throughout the site. Construction materials and debris pose a hazard to workers, as the materials may fall onto workers and injure them. The debris may also cause workers to trip.</p>

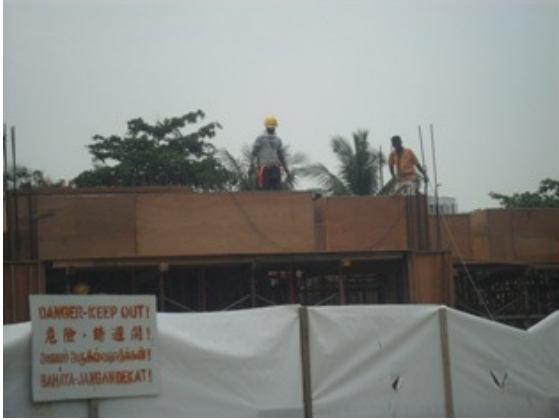
Unsafe work at height	Workers erected formwork (concrete mould) structures without fall protection systems, exposing them to the risk of falling off the structure.
2

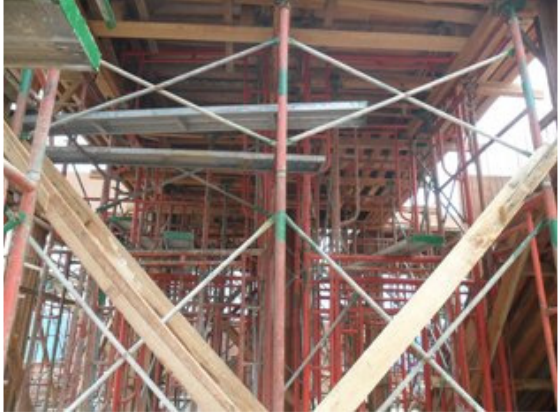
Unsafe work platform	A work platform on scaffolding was not secured to the scaffolding structure, exposing workers to the risk of falling to the ground.

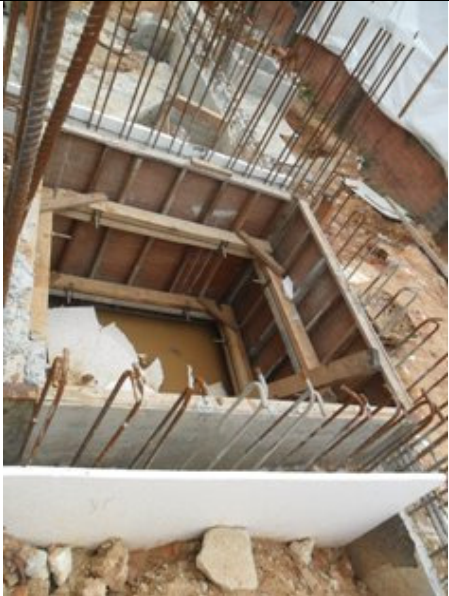
3

Unprotected openings	The opening of an excavated pit (with a depth of 1.2m) was not protected by proper barricades, exposing workers to the risk of falling into the pit.
---	---	----------------------	--
